**Flood Control Project Maintenance
Levee Inspections**

Maintenance Issue Types Only, Levee Inspection Report By Mile - Spring 2019

Levee District No. 0003 (Glenn County)

Waterway	Bank	Unit Miles	Inspection Start/End	Inspector
Unit No. 01 Glenn County Sacramento River	Left	11.97	03/21/2019 03/21/2019	Makar Sokol

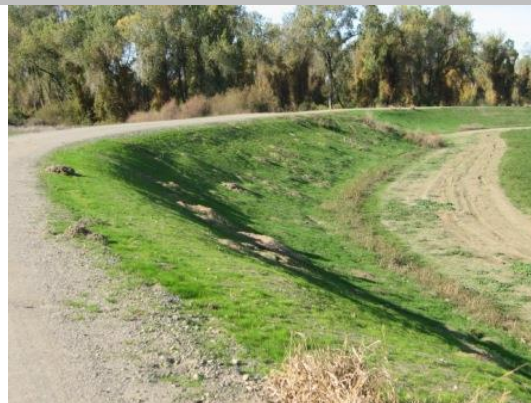
Photo 1 of 1 : SP_2019_LD0003_27_3_20190319_00001.jpg

View of squirrel holes along the landside slope.

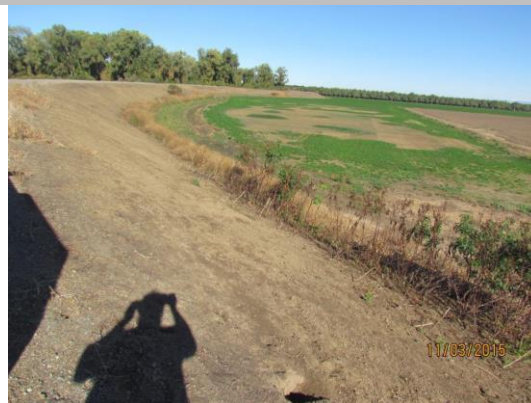
Photo 1 of 1 : SP_2019_LD0003_27_51_20190319_00023.jpg

View of the rodent holes along the landside slope.

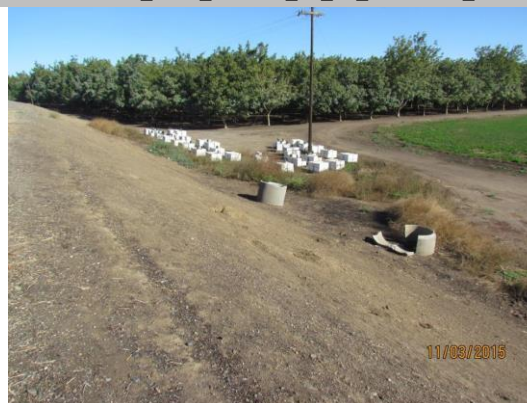
Photo 1 of 1 : SP_2019_LD0003_27_52_20190319_00024.jpg

View of the rodent holes along the landside slope.

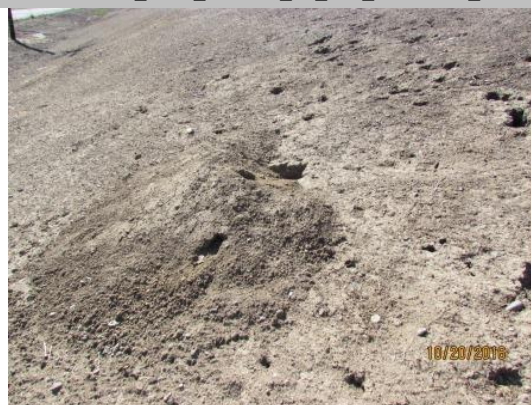
Photo 1 of 1 : SP_2019_LD0003_27_104_20190319_00056.jpg

View of the rodent holes along the landside slope.

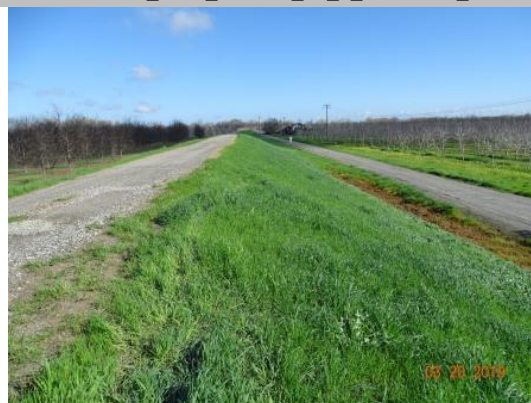
Photo 1 of 1 : SP_2019_LD0003_27_8_20190322_00100.jpg

LM Start	1.78	Rating **	M	Issue No.	8
LM End	2.14	Issue Type +	Ma	Location *	LS
Category	Earthen Levee			GPS Latitude/Longitude	
				Start	End
Item	Vegetation			39.402225 °	39.406402 °
				-122.002053 °	-121.999907 °
DWR ID	DWR_LD0003_01_s_2019_8				
Comment Code					
V1 : Control annual grass and weeds on the levee slopes and easements.					
Inspector Comment

View of the vegetation on the landside slope, facing upstream.

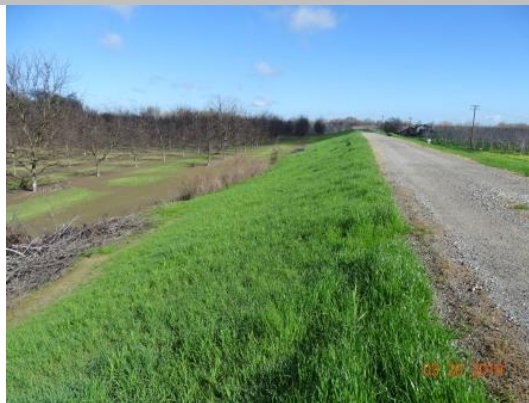
Photo 1 of 1 : SP_2019_LD0003_27_58_20190322_00101.jpg

View of the vegetation on the waterside slope, facing upstream.

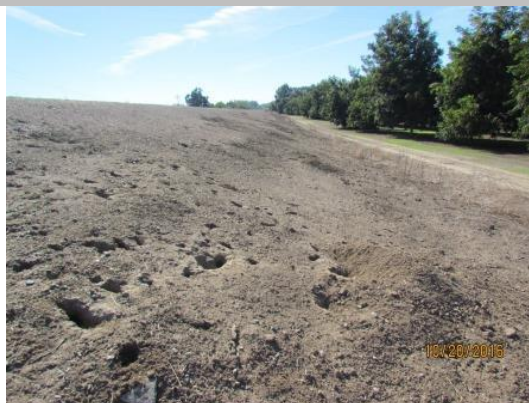
Photo 1 of 1 : SP_2019_LD0003_27_103_20190319_00055.jpg

LM Start	1.83	Rating **	U	Issue No.	103
LM End	2.35	Issue Type +	Ma	Location *	WS
Category	Earthen Levee			GPS Latitude/Longitude	
				Start	End
Item	Animal Control			39.402851 °	39.406414 °
				-122.001958 °	-121.995993 °
DWR ID	DWR_LD0003_01_f_2016_103				
Comment Code					
A1 : Exterminate rodents and backfill and compact or grout burrows.					
Inspector Comment

View of the rodent holes along the waterside slope.

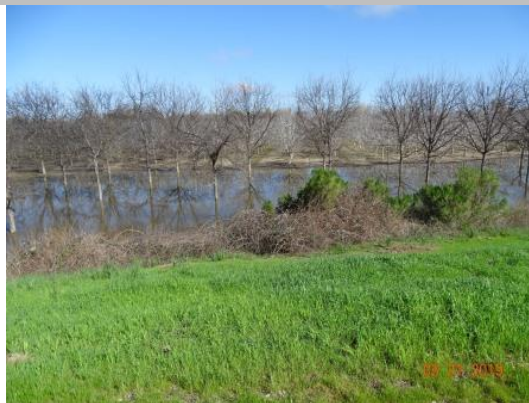
Photo 1 of 1 : SP_2019_LD0003_27_59_20190322_00102.jpg

LM Start	2.16	Rating **	M	Issue No.	59
LM End	2.16	Issue Type +	Ma	Location *	WS
Category	Earthen Levee			GPS Latitude/Longitude	
				Start	End
Item	Vegetation			39.406443 °	39.406443 °
				-121.999634 °	-121.999634 °
DWR ID	DWR_LD0003_01_s_2019_59				
Comment Code					
V2 : Remove the wild growth other than native grasses from the levee slopes.					
Inspector Comment					
Clear brush from WS slope and toe.

View of the wild growth along the waterside slope and toe, facing north.
(Spring 2019)

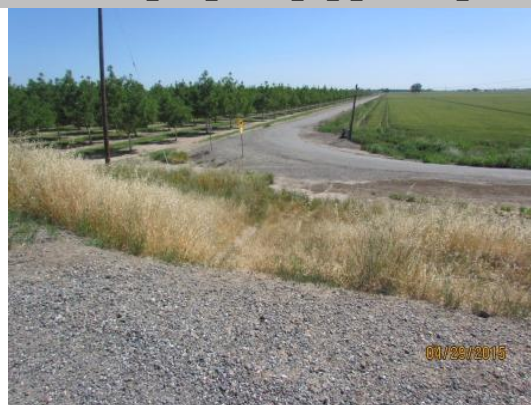
Photo 1 of 1 : SP_2019_LD0003_27_9_20190319_00006.jpg

LM Start	3.39	Rating **	M	Issue No.	9
LM End	3.39	Issue Type +	Ma	Location *	LS
Category	Earthen Levee			GPS Latitude/Longitude	
				Start	End
Item	Slope Stability			39.418382 °	39.418382 °
				-121.992480 °	-121.992480 °
DWR ID	DWR_LD0003_01_s_2012_9				
Comment Code					
S3 : Repair the levee slope damaged by vehicle traffic and prevent access where possible.					
Inspector Comment					
Repair the erosion along the landside slope and prevent vehicle access.

View of the vehicle erosion along the landside slope.

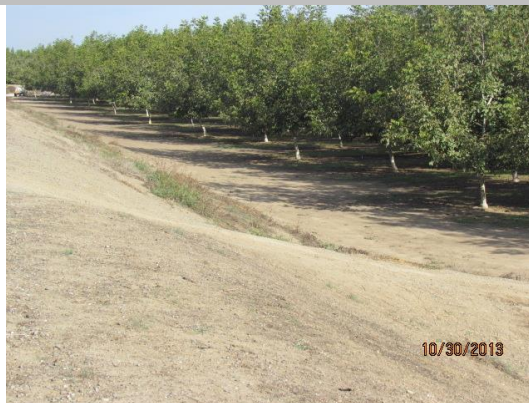
Photo 1 of 1 : SP_2019_LD0003_27_64_20190319_00031.jpg

View of the rodent activity along the landside slope.

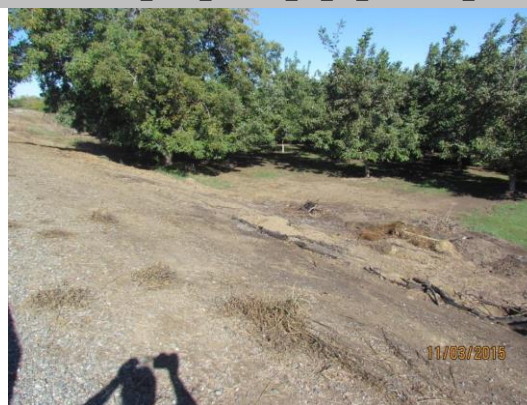
Photo 1 of 1 : SP_2019_LD0003_27_21_20190319_00011.jpg

View of the rodent holes along the landside slope.

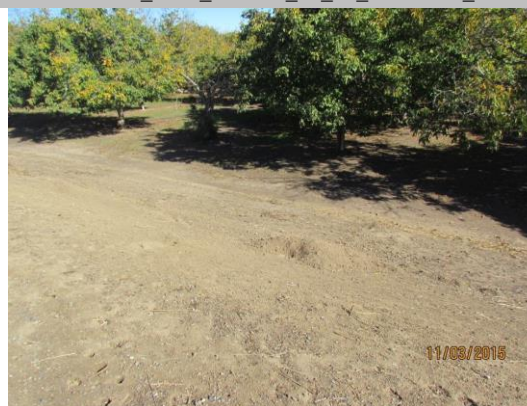
Photo 1 of 1 : SP_2019_LD0003_27_70_20190319_00037.jpg

View of the rodent holes along the landside slope.

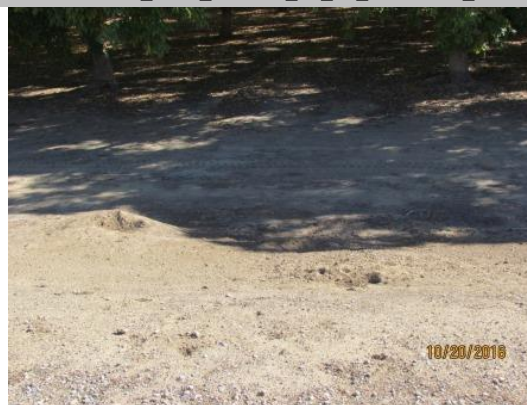
Photo 1 of 1 : SP_2019_LD0003_27_62_20190319_00029.jpg

View of the rodent holes along the landside slope.

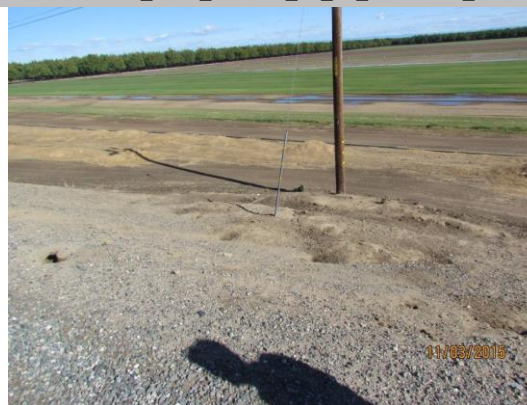
Photo 1 of 1 : SP_2019_LD0003_27_71_20190319_00038.jpg

View of the rodent holes along the landside slope.

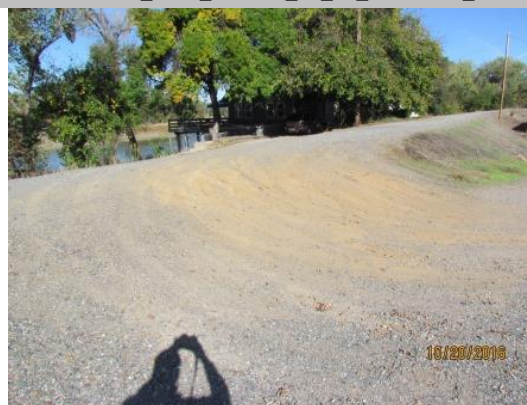
Photo 1 of 1 : SP_2019_LD0003_27_34_20190319_00015.jpg

LM Start	6.57	Rating **	M	Issue No.	34
LM End	6.57	Issue Type +	Ma	Location *	LS
Category	Earthen Levee			GPS Latitude/Longitude	
				Start	End
Item	Slope Stability			39.462505 °	39.462505 °
				-121.992698 °	-121.992698 °
DWR ID	DWR_LD0003_01_s_2012_34				
Comment Code					
S3 : Repair the levee slope damaged by vehicle traffic and prevent access where possible.					
Inspector Comment

View of slope instability caused by vehicle traffic.

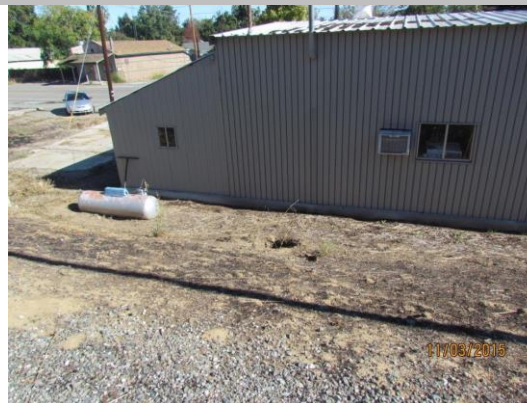
Photo 1 of 1 : SP_2019_LD0003_27_76_20190319_00042.jpg

LM Start	6.61	Rating **	U	Issue No.	76
LM End	6.61	Issue Type +	Ma	Location *	LS
Category	Earthen Levee			GPS Latitude/Longitude	
				Start	End
Item	Trim / Thin Trees			39.463185 °	39.463185 °
				-121.992657 °	-121.992657 °
DWR ID	DWR_LD0003_01_s_2019_76				
Comment Code					
T5 : Tree stumps.					
Inspector Comment					
Repair the burned out stump hole along the landside toe.

View of the burned out stump hole along the landside toe.

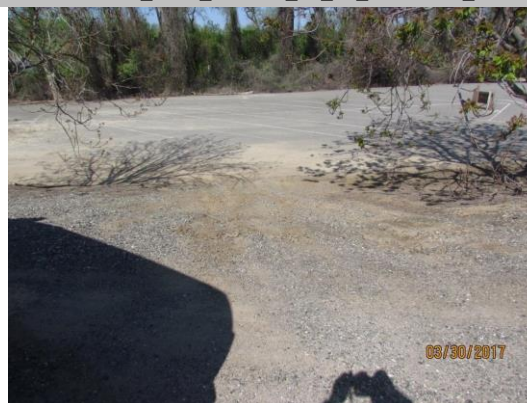
Photo 1 of 1 : SP_2019_LD0003_27_97_20190319_00054.jpg

LM Start	6.72	Rating **	M	Issue No.	97
LM End	6.72	Issue Type +	Ma	Location *	WS
Category	Earthen Levee		GPS Latitude/Longitude		
			Start	End	
Item	Slope Stability		39.464653 °	39.464653 °	
			-121.991789 °	-121.991789 °	
DWR ID	DWR_LD0003_01_f_2016_97				
Comment Code					
S3 : Repair the levee slope damaged by vehicle traffic and prevent access where possible.					
Inspector Comment					
Repair the vehicle ruts on the waterside slope.

View of the vehicle ruts on the waterside slope.

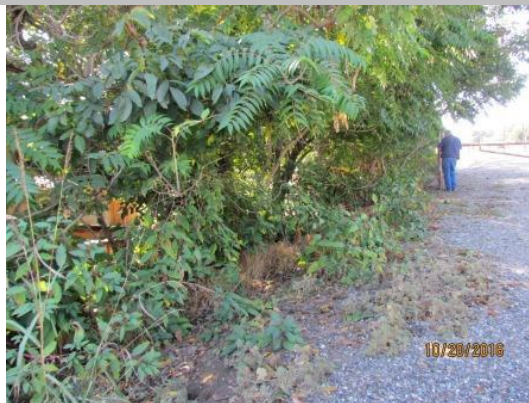
Photo 1 of 1 : SP_2019_LD0003_27_35_20190319_00016.jpg

View of the trees that are hanging over the landside slope of the levee.

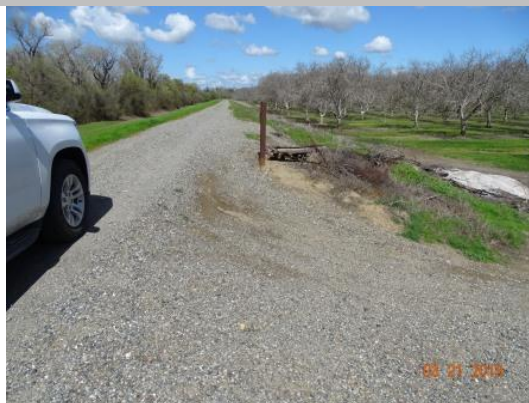
Photo 1 of 1 : SP_2019_LD0003_27_14_20190322_00105.jpg

LM Start	7.21	Rating **	M	Issue No.	14
LM End	7.21	Issue Type +	Ma	Location *	LS
Category	Earthen Levee			GPS Latitude/Longitude	
				Start	End
Item	Slope Stability			39.471658 °	39.471658 °
				-121.991245 °	-121.991245 °
DWR ID	DWR_LD0003_01_s_2012_14				
Comment Code					
S3 : Repair the levee slope damaged by vehicle traffic and prevent access where possible.					
Inspector Comment

View of the erosion caused by vehicle traffic along the landside slope and crown, facing upstream. (Spring 2019)

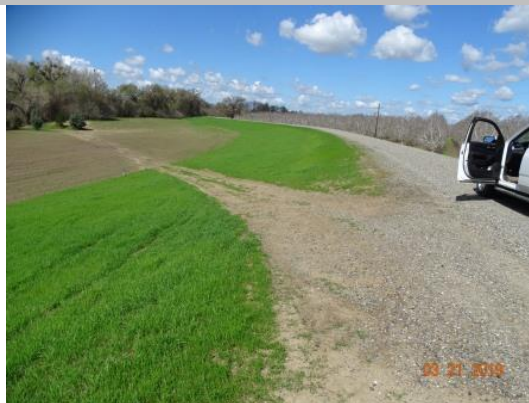
Photo 1 of 1 : SP_2019_LD0003_27_120_20190322_00109.jpg

LM Start	8.40	Rating **	M	Issue No.	120
LM End	8.40	Issue Type +	Ma	Location *	WS
Category	Earthen Levee			GPS Latitude/Longitude	
				Start	End
Item	Slope Stability			39.488423 °	39.488423 °
				-121.988727 °	-121.988727 °
DWR ID	DWR_LD0003_01_s_2019_120				
Comment Code					
S3 : Repair the levee slope damaged by vehicle traffic and prevent access where possible.					
Inspector Comment

View of the waterside slope damage caused by vehicle traffic, facing upstream. (Spring 2019)

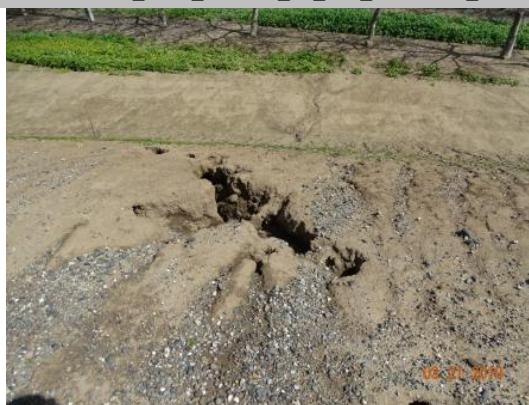
Photo 1 of 1 : SP_2019_LD0003_27_119_20190322_00108.jpg

LM Start	8.40	Rating **	U	Issue No.	119
LM End	8.40	Issue Type +	Ma	Location *	LS
Category	Earthen Levee			GPS Latitude/Longitude	
				Start	End
Item	Erosion / Bank Caving			39.488427 °	39.488427 °
				-121.988732 °	-121.988732 °
DWR ID	DWR_LD0003_01_s_2019_119				
Comment Code					
E2 : Schedule repair of erosion site prior to the next inspection.					
Inspector Comment					
Repair the erosion site and address the rodent activity.

View of the erosion caused by water runoff and rodent holes on the landside slope, facing east. (Spring 2019)

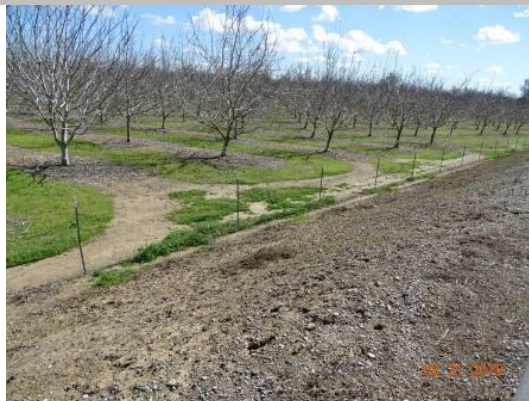
Photo 1 of 1 : SP_2019_LD0003_27_125_20190322_00111.jpg

View of the rodent holes along the landside slope, facing downstream.
(Spring 2019)

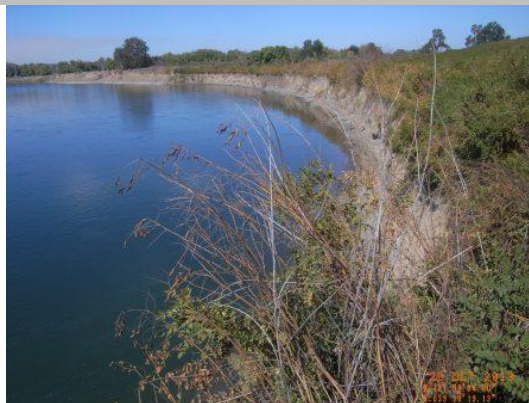
Photo 1 of 3 : SP_2019_LD0003_27_106_20190319_00058.jpg

Comment Code					
Inspector Comment					
2017 Site ID: SAC 172.0 L					
Status: Critical					
2017 Field Notes: Significant erosion in last year. Erosion is entering levee prism, at current erosion rate, one more large storm and the levee will be comprised. Upgraded to critical.					
Site History: 2007 - Getting close to the levee. Bank is clayey silt with clayey/silty toe. 2008 - Looks a little worse at the upstream end. 2009 - Some new erosion and slumping. 2010 - Some new erosion upstream of site, actively eroding at low flow. New bank swallow colony noted. 2011 - Significant erosion since last year, with an estimated 10 to 15 feet of berm lost. Large sections of the bank have slumped off. 2012 - Part of the site appears to be stabilizing, but still minor slumping in other locations. 2013 - Minor new erosion at toe.

USACE 2013 Photo #1

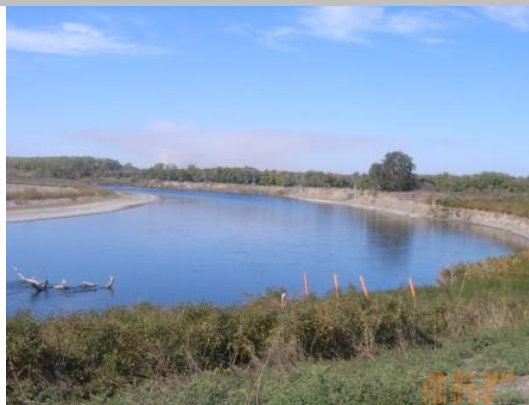
Photo 2 of 3 : SP_2019_LD0003_27_106_20190319_00059.jpg

USACE 2013 Photo #2

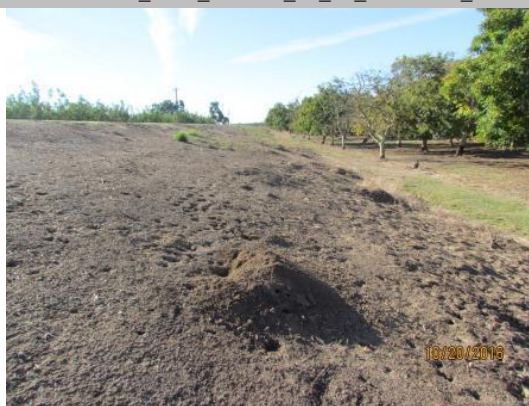
Photo 1 of 1 : SP_2019_LD0003_27_93_20190319_00050.jpg

View of the rodent holes along the waterside slope.

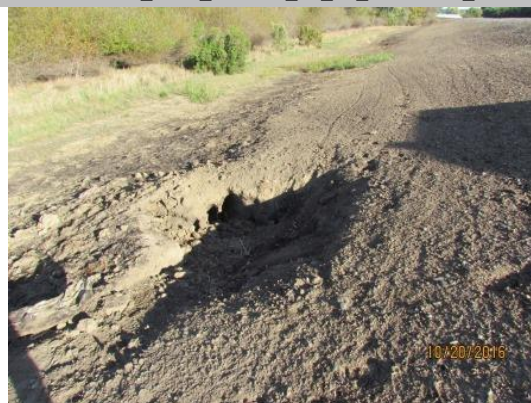
Photo 1 of 1 : SP_2019_LD0003_27_89_20190319_00049.jpg

LM Start	10.66	Rating **	U	Issue No.	89
LM End	10.66	Issue Type +	Ma	Location *	WS
Category	Earthen Levee			GPS Latitude/Longitude	
				Start	End
Item	Slope Stability			39.517553 °	39.517553 °
				-121.979132 °	-121.979132 °
DWR ID	DWR_LD0003_01_f_2016_89				
Comment Code					
S1 : Repair slope instability.					
Inspector Comment

View of a hole along the waterside slope that need to be backfilled and compacted.

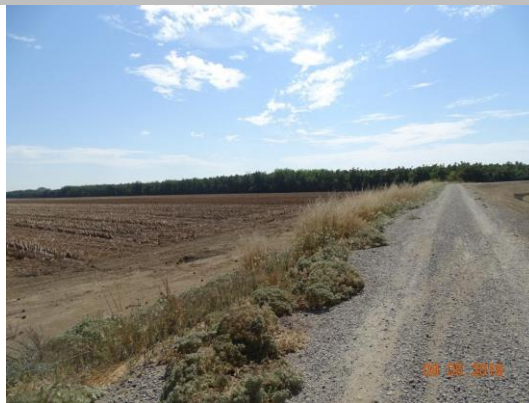
Photo 1 of 1 : SP_2019_LD0003_27_81_20190319_00046.jpg

View of the vegetation along the landside slope.

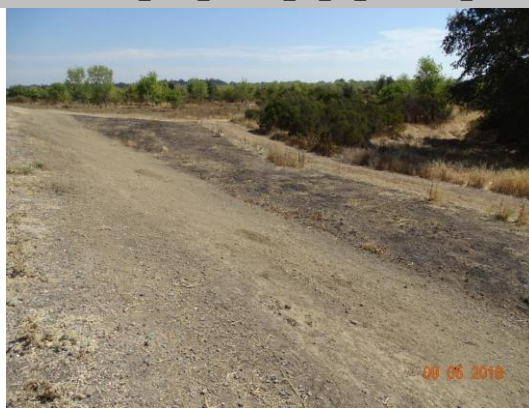
Photo 1 of 1 : SP_2019_LD0003_27_79_20190319_00045.jpg

LM Start	11.41	Rating **	U	Issue No.	79
LM End	11.41	Issue Type +	Ma	Location *	LS
Category	Earthen Levee			GPS Latitude/Longitude	
				Start	End
Item	Animal Control			39.526822 °	39.526822 °
				-121.974562 °	-121.974562 °
DWR ID	DWR_LD0003_01_f_2018_79				
Comment Code					
A1 : Exterminate rodents and backfill and compact or grout burrows.					
Inspector Comment					
Repair the rodent holes along the landside slope.

View of the rodent holes along the landside slope.
